The Journal of Caribbean Ornithology

Vol. 32:4–10. 2019

Retrofitting power poles to prevent electrocution of translocated Ridgway's Hawks (*Buteo ridgwayi*)

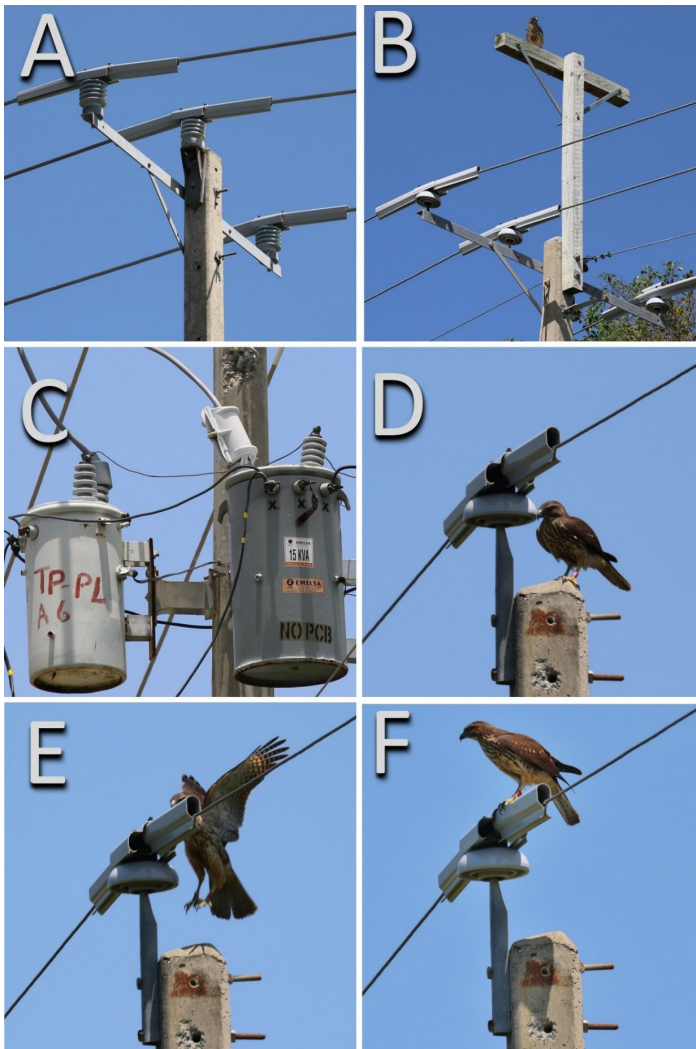
free of any retrofit errors. Most correctly retrofitted poles originally lacked any jumpers or pole-mounted equipment (Fig. 2), and thus were relatively easy to retrofit. On more complex poles, we observed some correct retrofitting. We also observed poles with single error types ($n = 37$ mitigation, application, or improvisation errors), and poles with various combinations of two of these error types ($n = 17$) (Table 1, Fig. 3). Mitigation plan errors involved the absence of covers on dead ends, fused cutouts, surge arresters, and transformer bushings; application errors consistently involved the absence of jumper covers, usually when other insulation was present; improvisation errors includ-

Fig. 2. Correctly retrofitted power poles. (A) Three-phase pole with all energized wires covered. (B) Three-phase pole with all energized wires covered and a supplemental perch (the supplemental perch alone would not correctly retrofit the pole). (C) Transformers correctly retrofitted with bushing covers and jumper covers on energized components (the uncovered bushings and jumpers are not energized). (D–F) A Ridgway's Hawk moving from (D) concrete pole top, through (E) the air gap between the grounded pole top and the energized wire, to (F) perching on a conductor cover preventing contact with the energized wire.

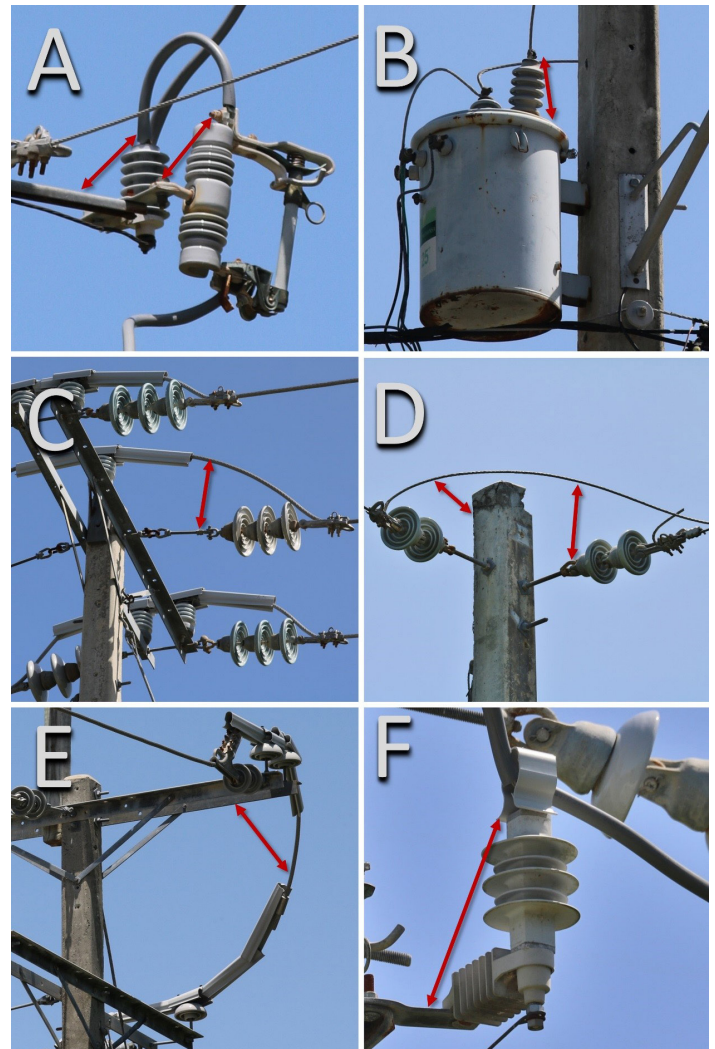
Fig. 3. Errors in retrofitting power poles. (A and B) Mitigation plan errors: appropriate insulation existed but was not specified for use. (C and D) Application errors: insulation existed and was specified, but was not installed correctly. (E and F) Improvisation errors: insulation was modified for an application beyond the manufacturer's recommendation. Red arrows indicate phase-to-ground contact risks in each frame. In the cases illustrated here, the lightning arrester (A, left arrow), cutout (A, right arrow), transformer bushing (B), jumpers (C, D, E), and lightning arrester connection (F) are energized and exposed in proximity to grounded poles, arms, or brackets, allowing electrocution risk to persist.

ed using scraps of conductor covers to cover jumpers and surge arresters, and using small lengths of PVC pipe to cover conductors (Fig. 3). Improvised covers appeared secure, but some were too small to cover the entire jumper or the energized top of the equipment upon which they were installed. We also observed supplemental perches on 43 poles.

In the Punta Cana area, budget constraints forced a triage-style approach to prioritizing retrofitting (TIH pers. obs.). Within this triage approach, deadend covers were not included in the mitigation plan because the relatively small size of Ridgway’s Hawks made simultaneous phase-to-phase contact between deadend wires or phase-to-ground contact across deadend insulators relatively unlikely. Though Ridgway’s Hawks are at relatively low electrocution risk when deadend structures lack deadend covers, and though we do not know of any electrocutions occurring on this type of structure, higher risk persists on this configuration for larger birds in the area. Given that retrofitting budgets will remain limited in the foreseeable future, ongoing mitigation planning will need to continue to weigh the electrocution risks and retrofitting costs on deadends against other pole-top locations to continue to yield the greatest conservation impact per dollar spent.
