Case 4: Wastewater Treatment and Reuse for Golf Course Irrigation in a Large Beach Resort in Punta Cana, Dominican Republic

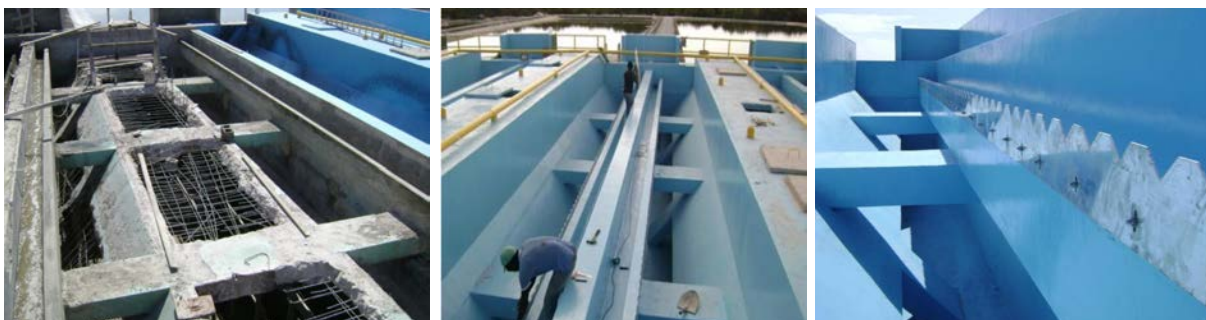
Figure 4 shows some of the construction works and retrofitting that took place to improve the performance of the 4 UASB of the treatment plant.

Figure 4: Improvements in UASB reactors for higher treatment efficiency

- All screens were repaired and adjusted, according to the local conditions
- UASB reactors were modified to insure proper hydraulic retention times, good phase separation (liquid/gas) and even flow distribution among them
- The flow in the stabilisation ponds was improved to avoid dead zones (areas with stagnated water)
- The filtration system (post treatment) was rehabilitated and the chlorine gas disinfection system was replaced by a new one that uses chlorine in liquid form.

Success factors and lessons learned The efficiency of the UASB reactors at the initial evaluation of the system was as follows: BOD₅ 18% - 45%, COD 12% - 45% and TSS 25% - 45%. After all the improvements were implemented, the efficiency rose to BOD₅ 67%, COD

65% and TSS 70%. These efficiencies are congruent with typical efficiency ranges reported in the literature for UASB reactors of 65% - 75%.

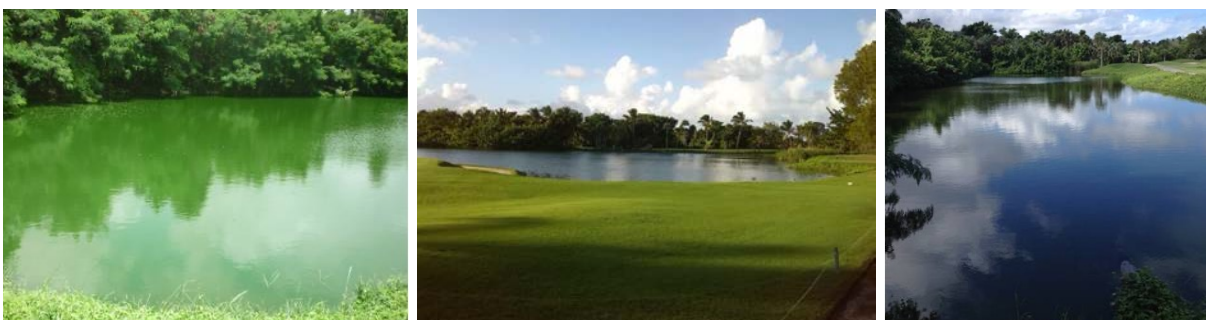
Figure 5: Improvement in the quality of water in the lakes

Additionally, the algae count was significantly reduced once the treatment plant was operating in its new condition (See Table 2) and the water lakes in the golf course where the treated effluent is discharged improved visibly, changing from green colour due the excess of algae to blue (See Figure 5).
